# Design, Ancillary Testing, Analysis, and Fabrication Data for the Advanced Composite Stabilizer for Boeing 737 Aircraft

## Volume I - Technical Summary

# NASA Contractor Report 3648

R. B. Aniversario, S. T. Harvey,  
J. E. McCarty, J. T. Parsons,  
D. C. Peterson, L. D. Pritchett,  
D. R. Wilson, and E. R. Wogulis  
*Boeing Commercial Airplane Company*  
*Seattle, Washington*

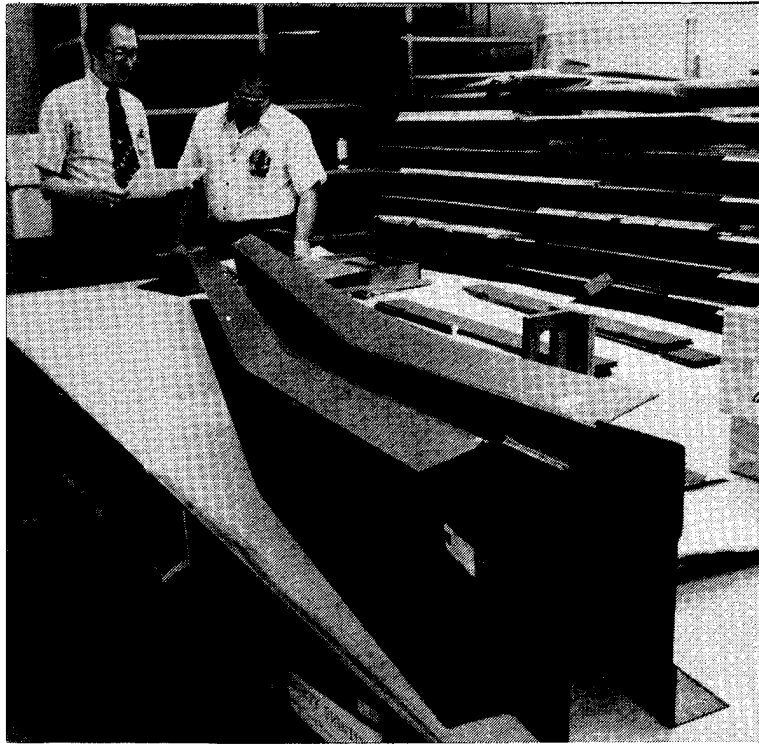
*Figure 42. Stub Box Front Spar—Completed Details Being Inspected*

The Test 21 stub box of the ancillary test program was used for manufacturing verification. Figures 42 through 47 show components in fabrication and assembly.

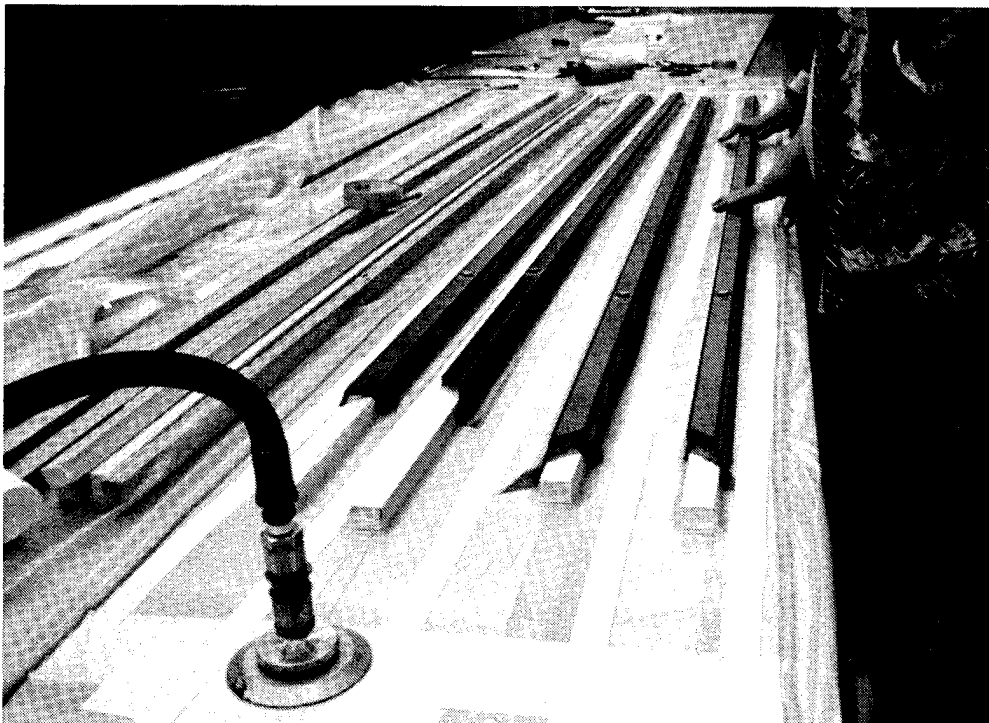
*Figure 43. Stub Box I-Stiffened Skin Panel—Layup of I-Stiffeners*

- The first production verification I-stiffened skin panel provided two major problems: excessive panel warpage and unacceptable porosity on the tool side skin surface. The warpage was approximately halved, 1.40 cm (0.55 in) to 0.76 cm (0.30 in), by substituting woven fabric for unidirectional tape along the stringer top (fig. 30, sec. 5.1). Skin surface porosity was reduced to a level that allowed routine finishing to provide an aerodynamically sound surface by using tows of fiberglass yarn to provide paths for improved air evacuation on the toolside during bagging and cure. This procedure, using fiberglass yarn in proportion to layup area, has been incorporated into the process specification.
